# FUTURE FISHERIES IMPROVEMENT PROGRAM

## BIENNIAL REPORT

Summary of program activities for the period November 1, 2016 to October 31, 2018

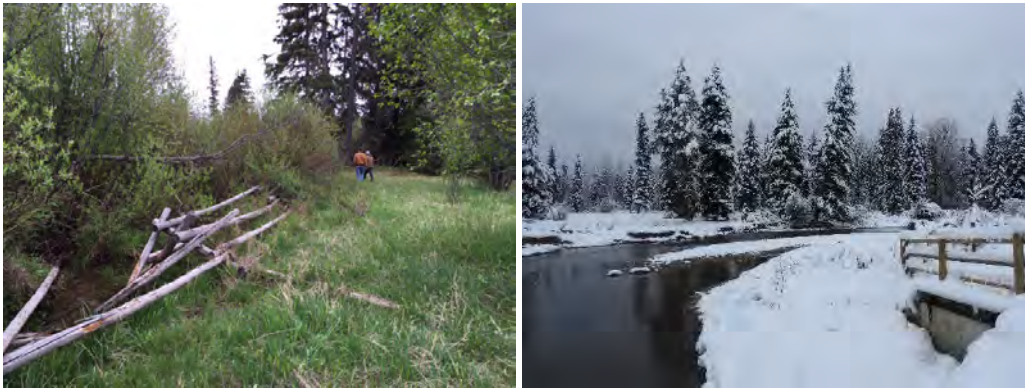
**FIGURE 31. FAILING JACKLEG FENCE (L) AND NEW FENCE (R) ON MONTURE AND DUNHAM CREEKS.**

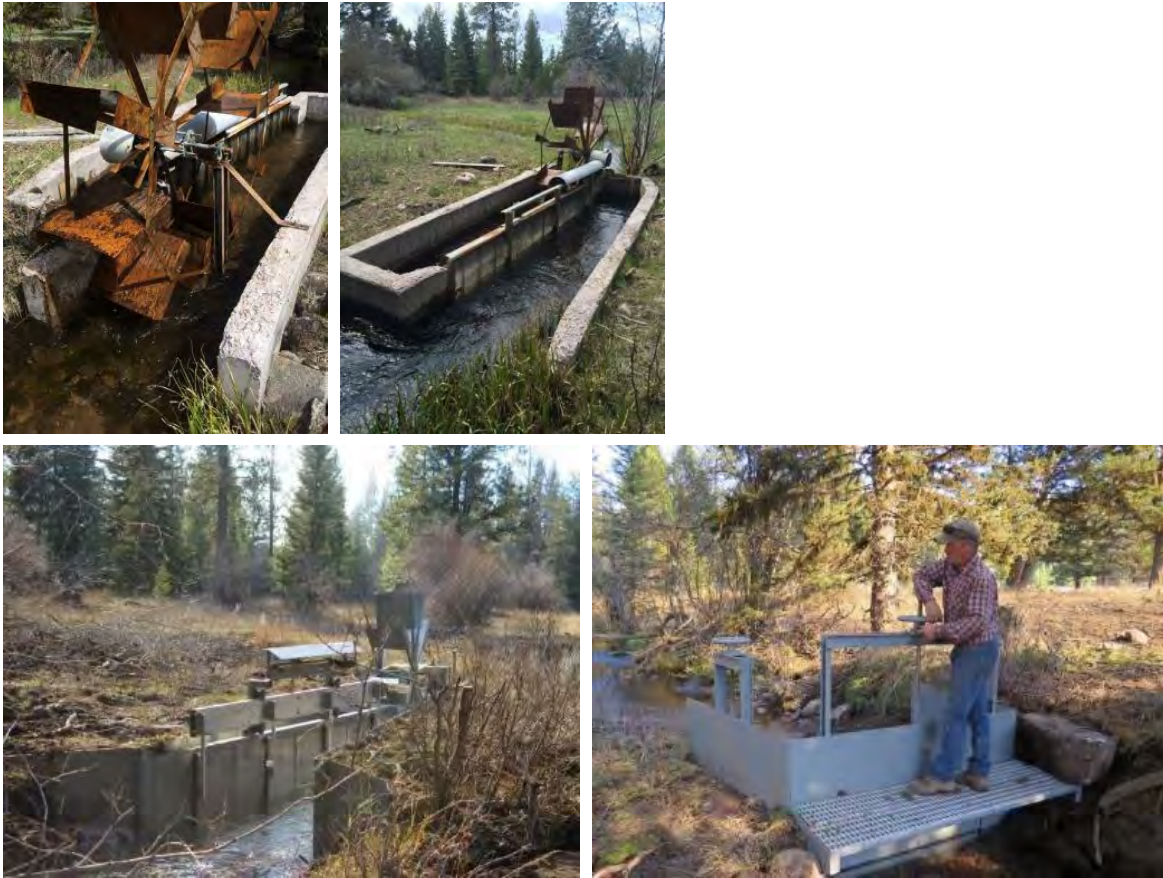
**FIGURE 35. OLD, NON-FUNCTIONAL FISH SCREEN (TOP) AND NEWLY INSTALLED SCREEN AND HEADGATE (BOTTOM).**

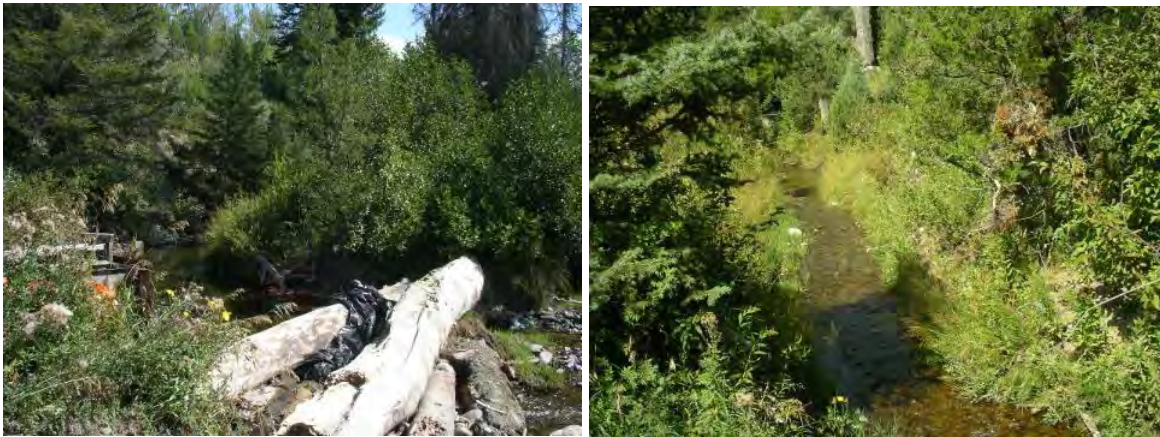
Pre-project photos document large logs with tarps backwatered the stream to deliver to the diversion (Figure 42). Considerable water leaked through the check boards at the head gate. The water savings with replacement of the leaking check boards with a Waterman gate would be beneficial and an appropriate use of FFIP funds.

**FIGURE 42. LOGS CHECKING COTTONWOOD CREEK'S FLOWS TO DELIVER WATER TO THE PIN-AND-PLANK HEAD GATE (L). WATER LEAKING INTO DITCH WHEN CHECK BOARDS WERE BLOCKING FLOW (R).**

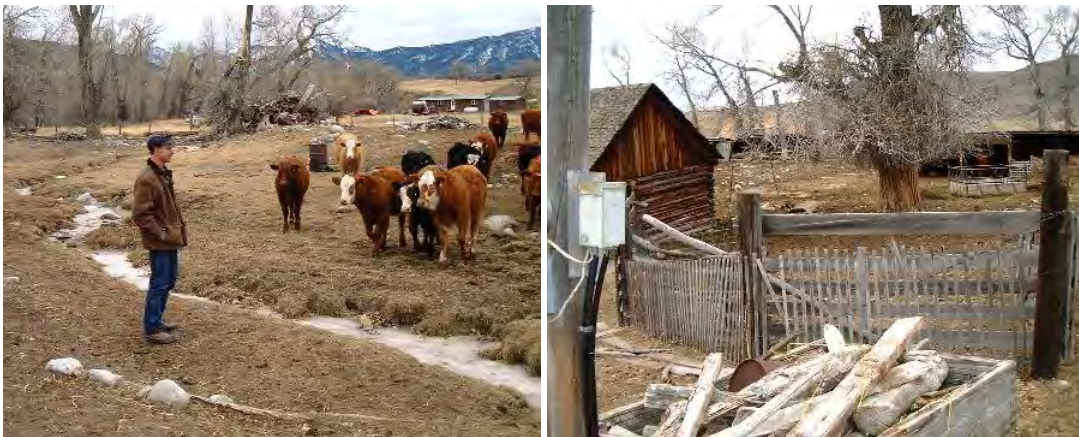
Pre-project photos illustrate the heavy use by livestock, trampled banks, and near lack of vegetation along the stream and within the corrals (Figure 44). This corral meets the EPA's criteria as a point source of pollution, and the combination of bank erosion and accumulation of manure made this stream a source of nutrients and sediment to the East Boulder River. In addition, in its pre-project condition, the stream provided exceptionally poor habitat for fish.

**FIGURE 44. PRE-PROJECT PHOTO FOR THE EAST BOULDER SPRING CREEK CHANNEL REALIGNMENT AND STOCK WATER PROJECT (L) AND CORRALS ON EAST BOULDER SPRING CREEK (R).**

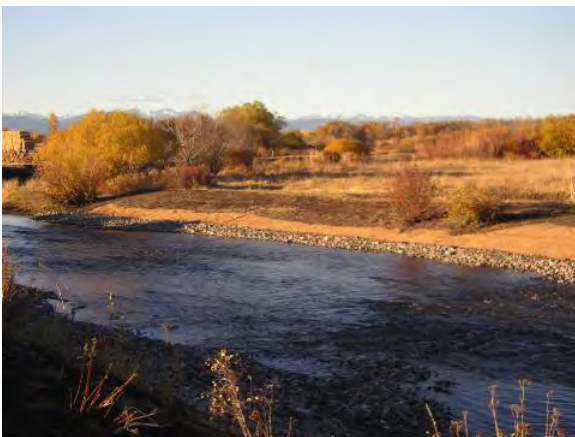
The first eroding bank had the potential to redirect flows against the footing of the bridge. The bank above the bank full margin was re-sloped to a 3:1 slope or less and covered with biodegradable erosion control blanket. Willows and dogwoods were planted at bank full edge, and the upper bank was planted with native grasses and sedges. The toe of the bank, below the bank full margin, was armored with natural cobble materials sized to resist the estimated 20-year flood modeled for that part of the river.

**FIGURE 48. POST-CONSTRUCTION PHOTO OF BANK 1.**

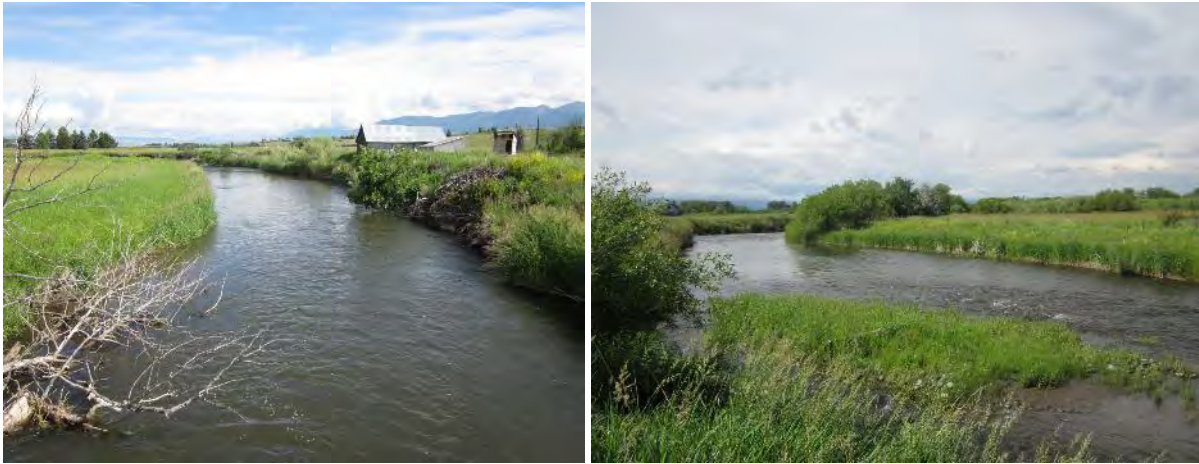
**FIGURE 52. BANK 1 ON THE EAST GALLATIN RIVER BANK RESTORATION PROJECT, VIEWED FROM DOWNSTREAM (L) AND REESTABLISHED GRAVEL BAR NEAR BANK 1 (R).**

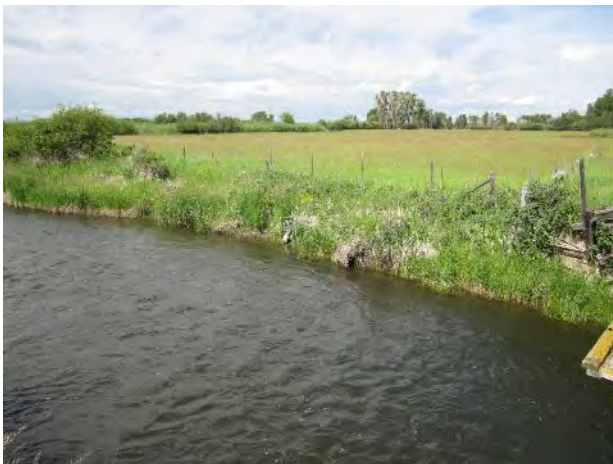
The second bank was treated with soil lifts encapsulated with erosion control fabric, revegetated, and cobbles large enough to be mobilized by a 50-year recurrence interval flood were placed at the toe of the bank. This treatment resulted in conditions like the first bank, with a bank angle of 90°, banks stabilized with grasses and sedges. The erosion control fabric decomposed with establishment of vegetation, and according to the landowner, the fabric has not been visible in years (Figure 53). Like the first bank, the rock toe had been transported away, resulting in an undercut bank.

**FIGURE 53. BANK 2 ON THE EAST GALLATIN RIVER RESTORATION PROJECT.**

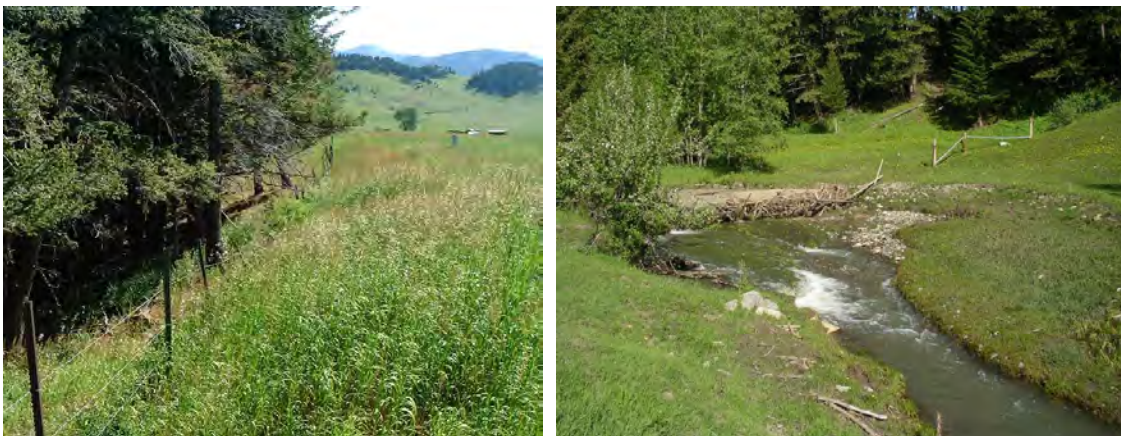
**FIGURE 66. FENCE AT TOP OF BENCH IN NEED OF REPAIR (L) AND EVIDENCE OF INCOMPATIBLE LIVESTOCK GRAZING ON NORTH FORK HORSE CREEK (R).**

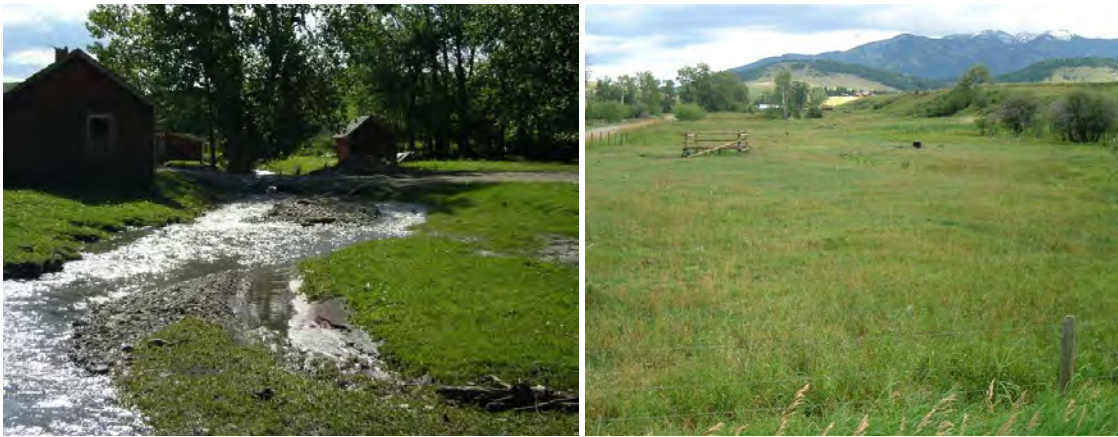
**FIGURE 67. DEGRADED STREAM HABITAT (L) AND DOWNSTREAM END OF PROPERTY SLATED FOR RIPARIAN FENCING (R).**

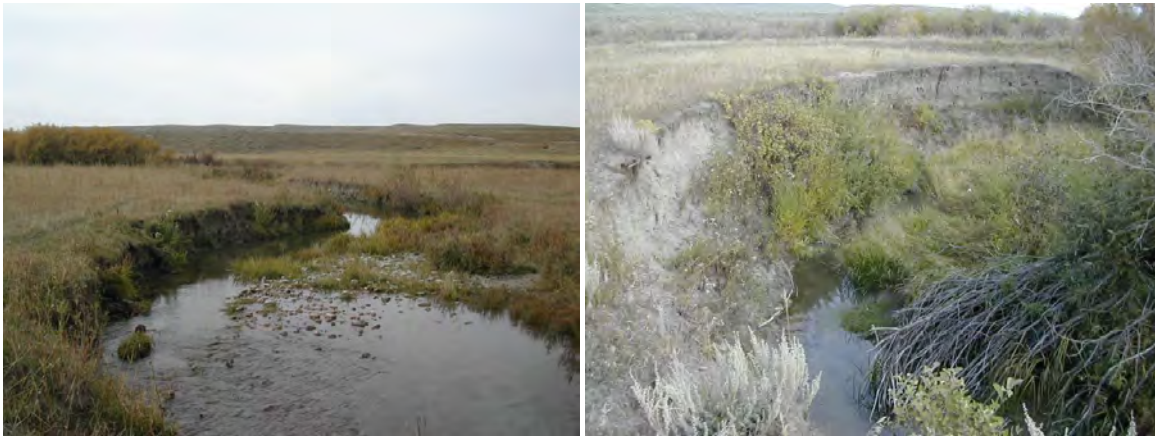
**FIGURE 90. OVERLY WIDE CHANNEL, BANK EROSION, AND RIPARIAN DEGRADATION (L) AND CHANNEL DOWNCUTTING (R) ON ELK CREEK IN 2002.**

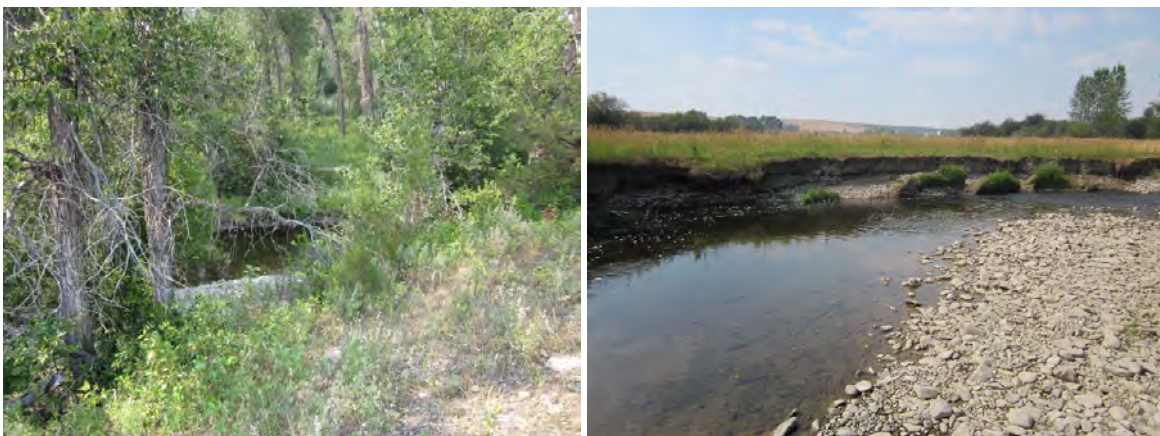
**FIGURE 94. RIPARIAN AREA WITH DENSE UNDERSTORY (L) AND HAY PASTURE ON WEST BANK OF RIVER AND BANK EROSION (R).**

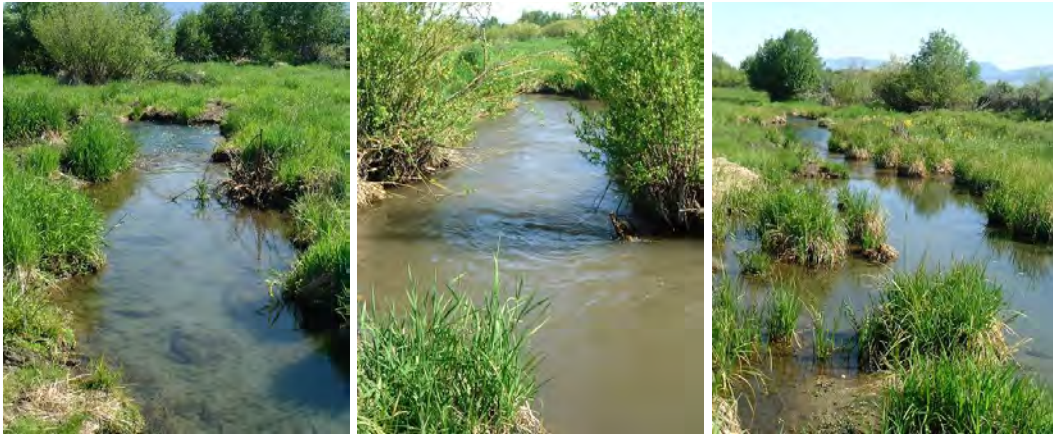
**FIGURE 103. SOUTH FORK ROSS CREEK PRE-PROJECT VIEW (L), TURBIDITY (C), AND HUMMOCKY, POORLY DEFINED CHANNEL.**

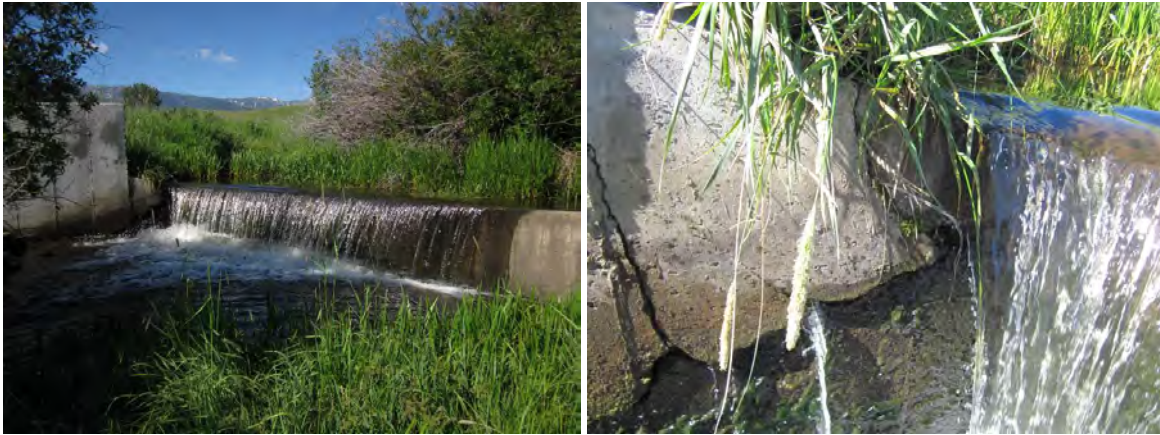
**FIGURE 108. THE THIEL CREEK FISH BARRIER (L) AND CRUMBLING CONCRETE ON THE RIGHT SIDE OF THE BARRIER (R).**

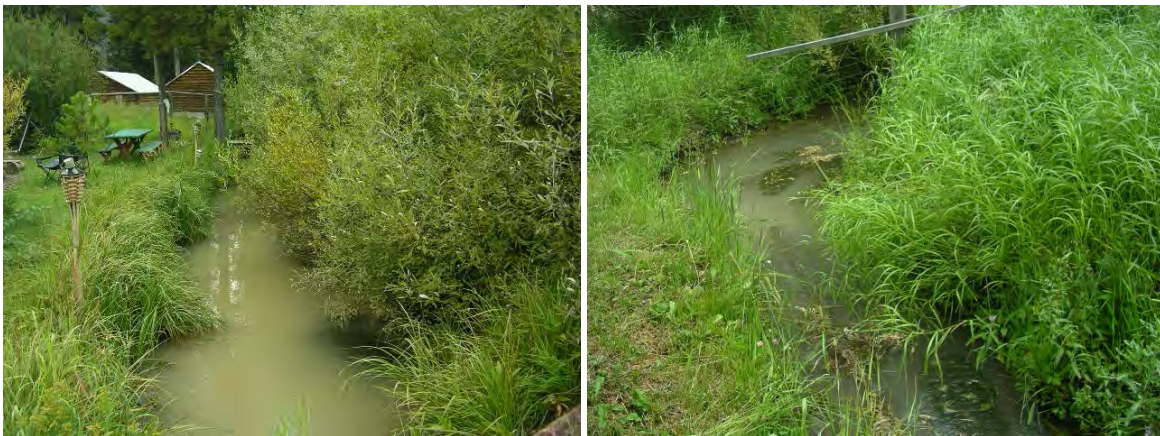
**FIGURE 113. VIEW OF WILLOW CREEK SHOWING THE OVERLY WIDE CONFIGURATION TYPICAL OF MUCH OF THE CHANNEL (L) AND POOR SPAWNING HABITAT.**
